AERIAL PHOTOGRAPHIC ANALYSIS OF FOUR RCRA WASTE DISPOSAL SITES

Chicago, Illinois

TS-AMD-85018/85603-15
December 1985

J. S. Duggan
Environmental Programs
Lockheed Engineering and Management Services Company, Inc.
Las Vegas, Nevada 89114

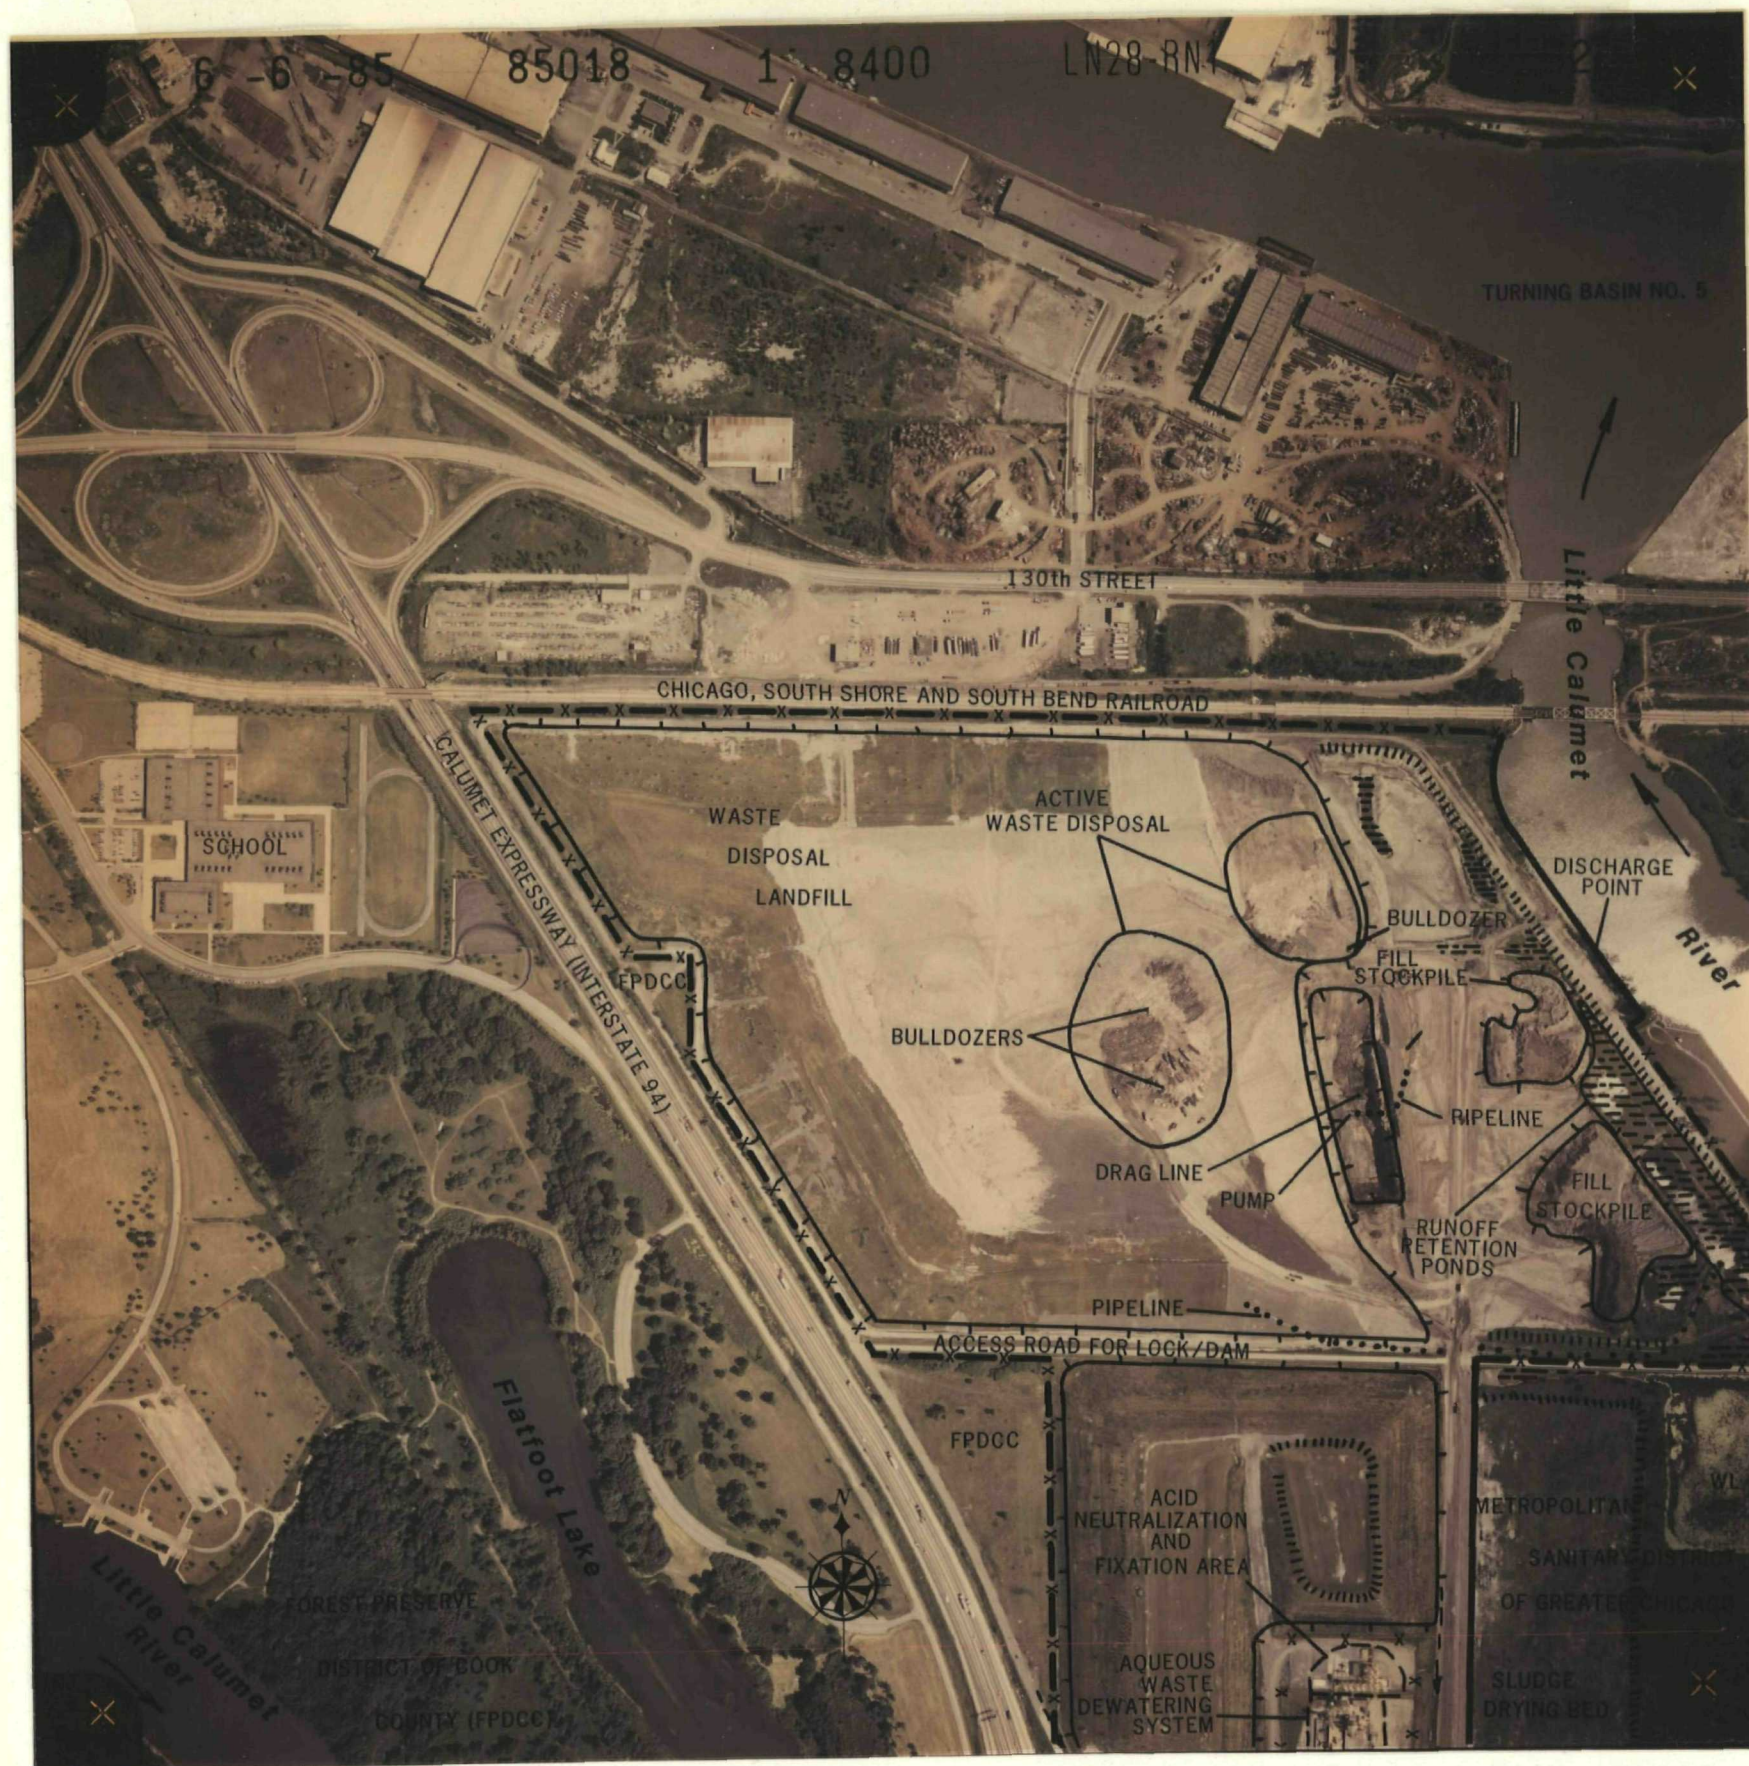
Figure 3. CID-Chemical Waste Management, June 6, 1985 (1 of 4). Approximate scale, 1 inch equals 700 feet.

The active solid waste disposal area is located in the northern section of the site (Figure 3). Numerous trucks hauling solid waste are present as are several bulldozers. Two large mounds, probably fill material, are located near the runoff retention ponds. A large pit approximately 770 by 245 feet is in the process of being excavated. A drag line is present at the bottom of the pit along with a pump to remove excess water. There is no evidence of waste disposal so this pit may be the source of the nearby fill stockpiles. One small pipeline is visible leading from the landfill mound to the retention ponds and may be part of the leachate collection system. A discharge point into the Little Calumet River is noted east of the retention ponds and is identified by the regional office as having an NPDES permit number. A plume from this point can be seen on Figure 4.

At the center of the site are two disposal facilities identified by information supplied by Region 5 as the acid neutralization and fixation area and the aqueous waste dewatering system (Figures 3 and 5). Both areas contain processing tanks and pipelines and both appear well maintained and clean. To the south but within the same security fence line is a drum receiving area containing 381 drums, but no spill stains are evident (Figure 5). In addition this portion of the site contains the offices for CID and ACE Disposal along with the associated maintenance facilities. Also, there is a laboratory, a synthetic fuels office, and a methane recovery plant. All of these areas appear clean and well maintained.

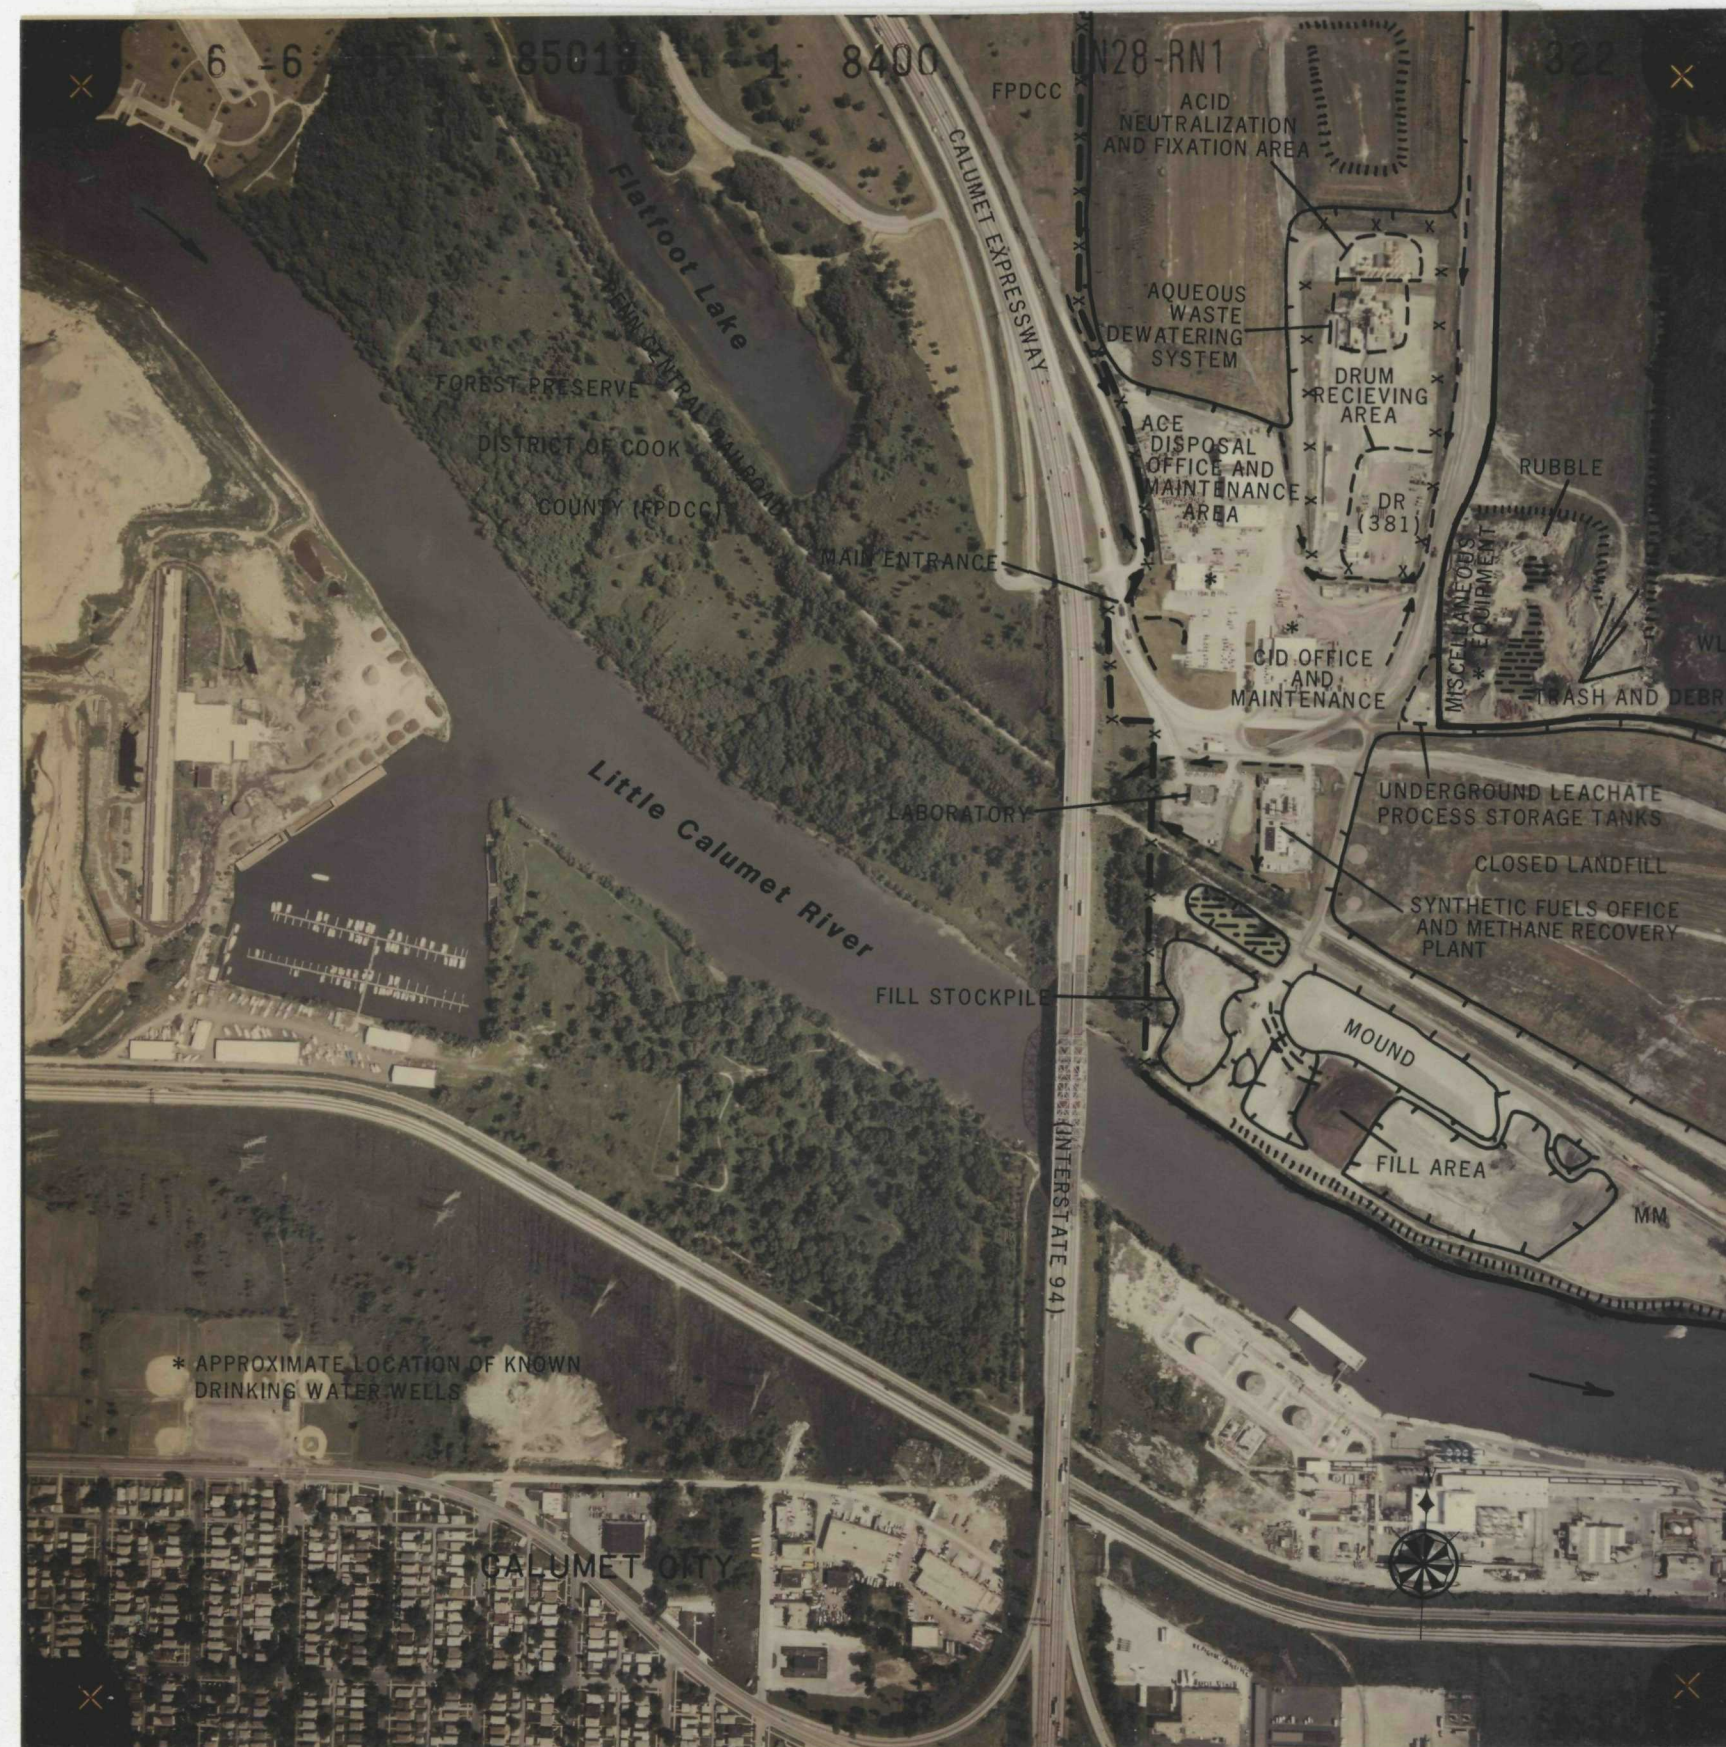
Figure 5. CID-Chemical Waste Management, June 6, 1985 (3 of 4). Approximate scale, 1 inch equals 700 feet.

East of the methane recovery facility is a large closed landfill (Figure 5 and 6). Surface drainage off this mound generally flows in all directions but along the east side it flows toward the Little Calumet River and along the north toward the wetlands of the MSDGC. Finally south of the Penn Central Railroad tracks that cross the site (Figures 5 and 6) are new fill areas situated between the tracks and the river. At the east end of this area (Figure 6) is a lined pit with a small pool of liquid at the bottom. A large excavation is a major feature in this portion of the site and it appears that some refilling has taken place (Figure 5). Also there are two large mounds of earthen material probably used for fill material. The excavation does not appear to be lined but there is no evidence of any seepage from groundwater or the river. Finally, a small impoundment about 385 by 100 feet and containing a green liquid, is present on the west side of this area but no inlet or outlet can be seen on the photograph.

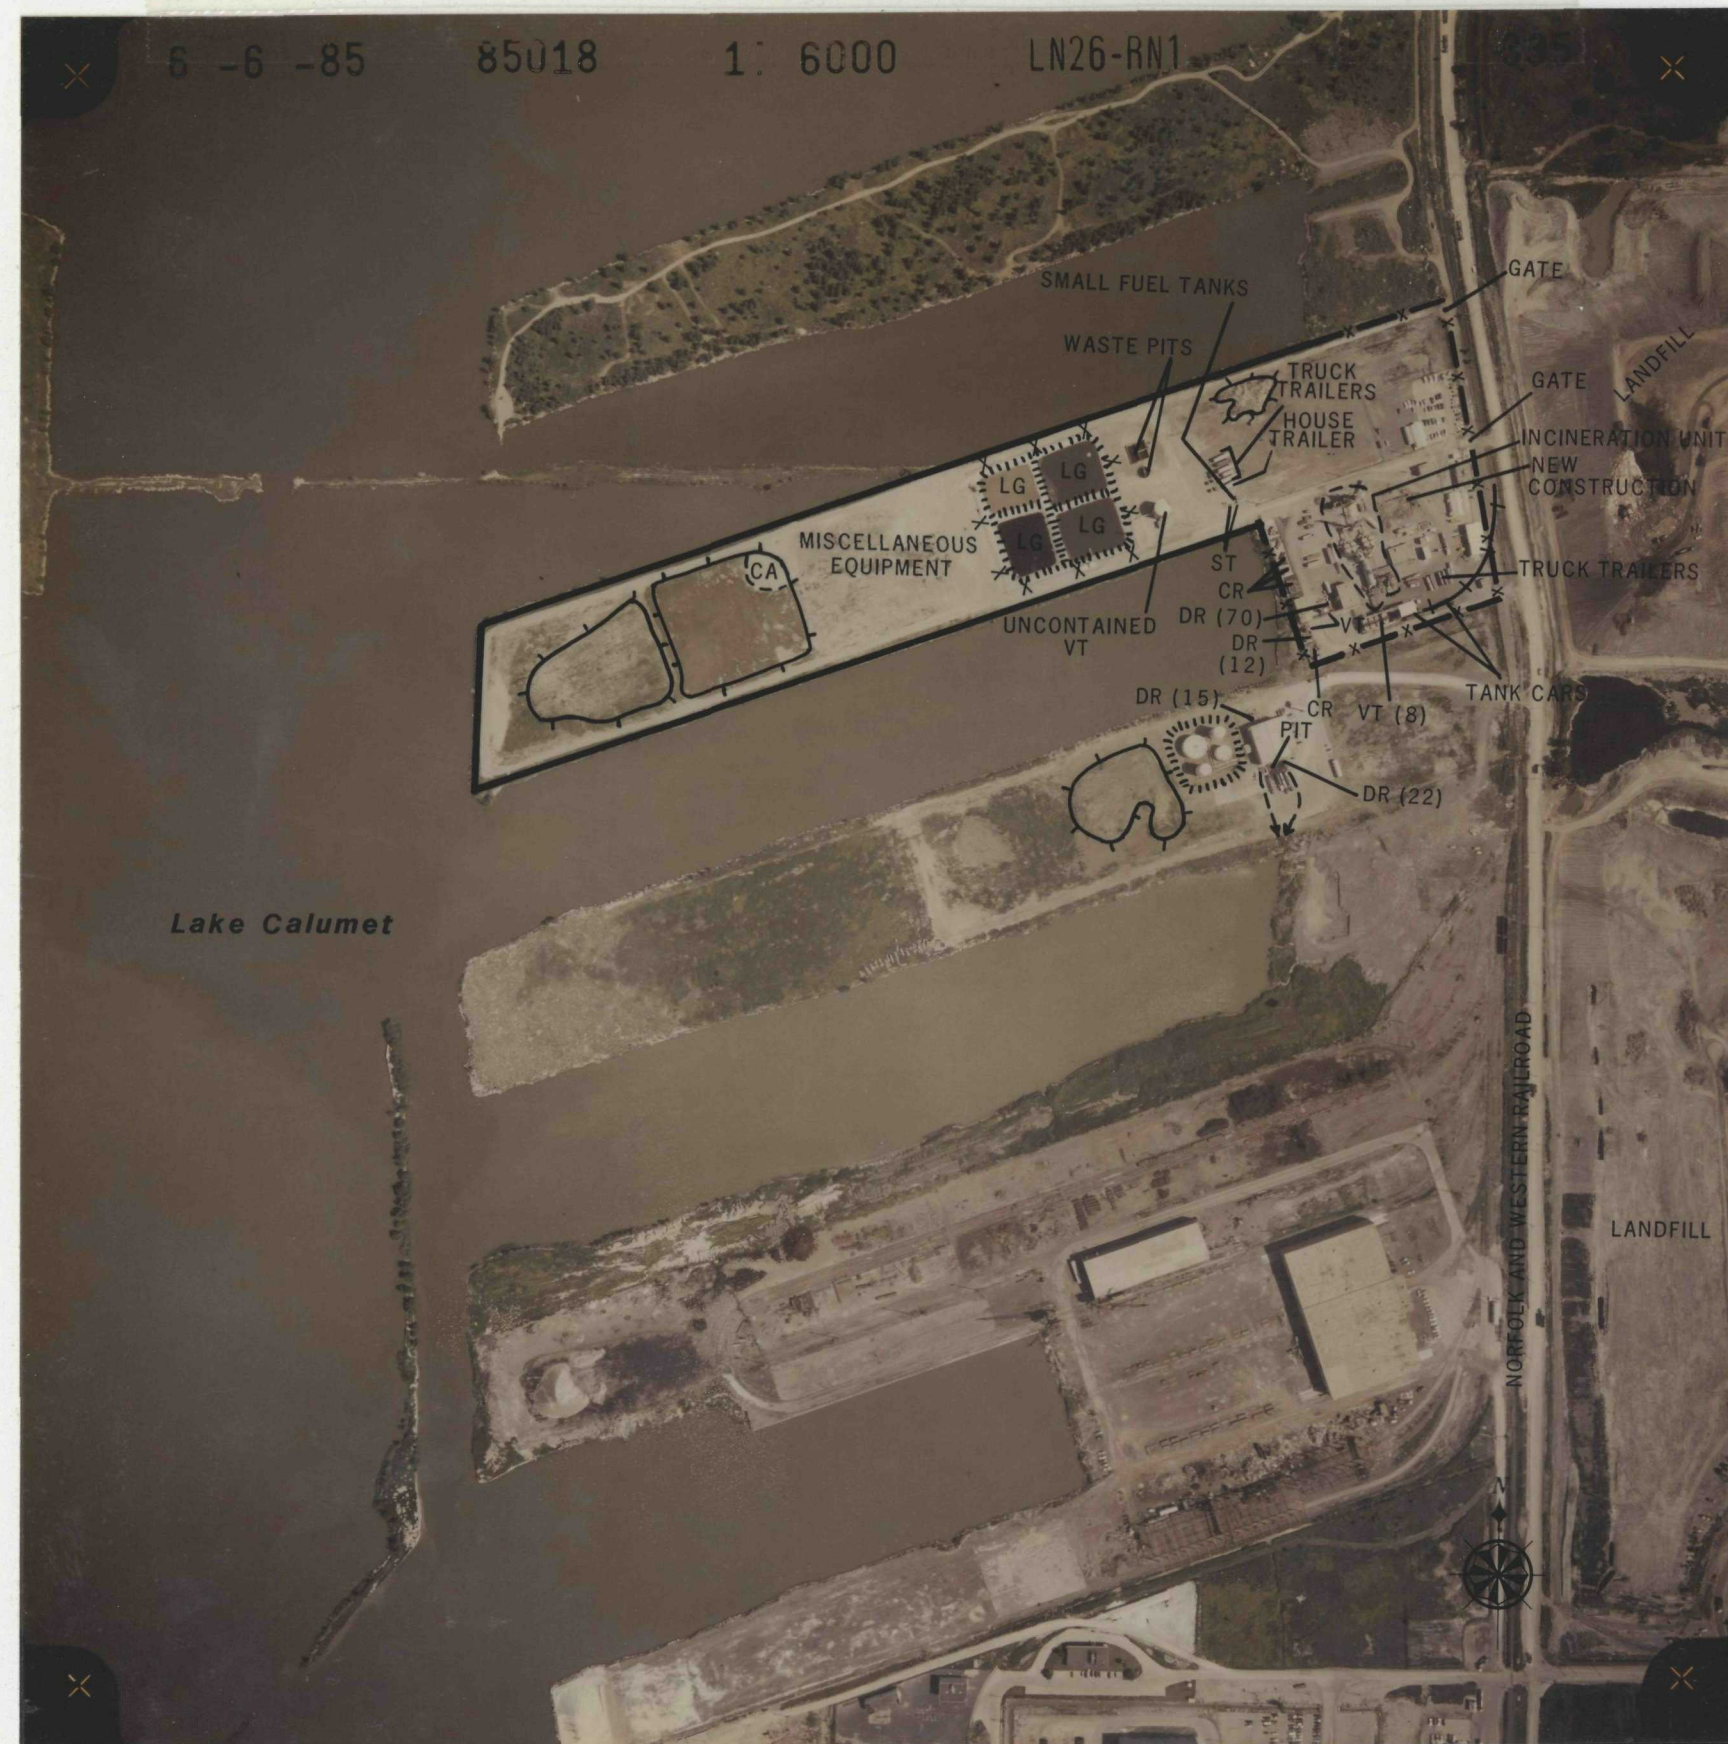
Figure 8. SCA Chemical Services Company, June 6, 1985. Approximate scale, 1 inch equals 500 feet.

The SCA Chemical Services Company facility is located on the east shore of Lake Calumet in Chicago, Illinois. The facility is approximately 30 acres in size and is situated on man-made fill area which extends out into the lake. The eastern portion of the site is secured with a fence. Access to the site is provided by a two lane gravel road and from a spur of the Norfolk and Western Railroad.

The site consists of a large incineration unit, four liquid waste lagoons, four small waste pits, and a variety of support buildings. In addition, there are two mounds at the west end of the site. The largest of these is approximately 2.45 acres while the other is 1.9 acres. It is not possible to determine if these mounds contain waste material. The four lagoons all contain liquid and all appear to be lined. The four lagoons occupy about 2.6 acres and are secured by a fence. An uncontained vertical storage tank just to the east is connected to the lagoons by a small pipeline. It would appear that a major spill from this tank could reach the lake. The four small waste pits each containing waste material, are located east of the lagoons. Two small (500 gallons or less) fuel tanks are also located in this same general area and there are spill stains around each. It would appear that in the event of a spill there would not be sufficient volume to reach the lake.

In the main area of the facility the predominant feature is a large incineration unit used to burn waste material. There are ten vertical storage tanks in this area along with 82 55-gallon drums. In addition, there are numerous crates and some open storage bins. A small area of construction is visible and it appears another building will be erected at this point. There is no evidence that any waste material has migrated offsite into the lake.

South of the SCA facility is a second waste disposal operation. Four tank-trucks are present offloading waste materials into a small waste pit. There are four well-contained storage tanks and 37 55-gallon drums. Drainage from the pit area could reach the lake as could spillage from some of the drums.

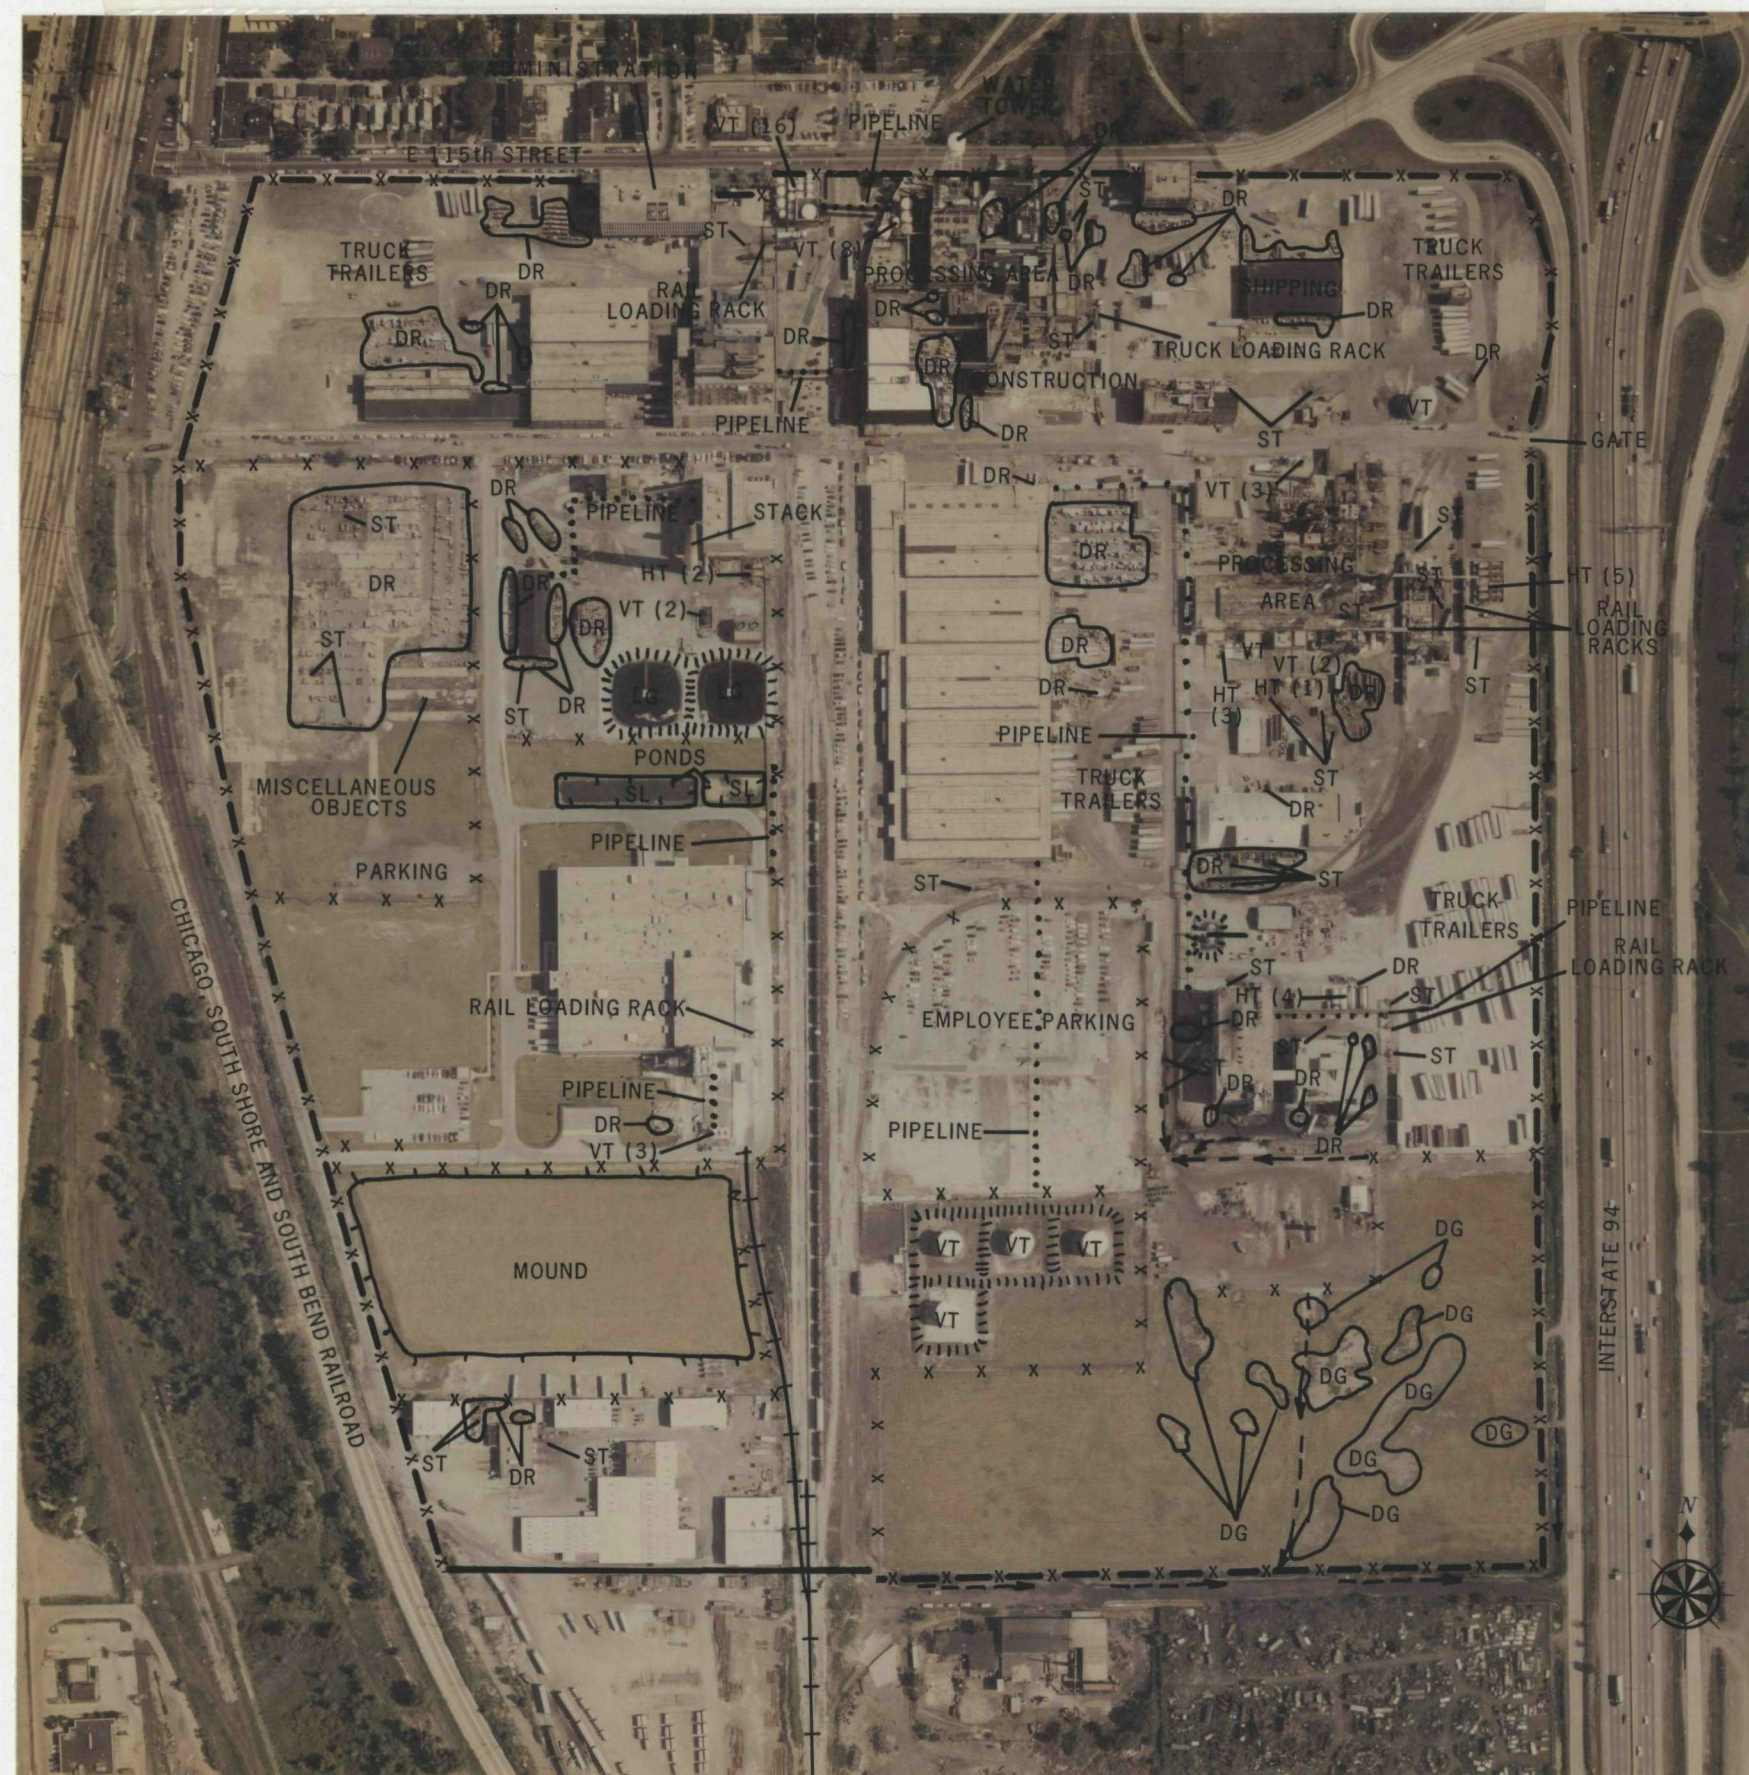
Figure 9. Sherwin-Williams Company, June 6, 1985. Approximate scale, 1 inch equals 355 feet.

The Sherwin-Williams Company facility is located in south Chicago, Illinois, and is involved in the production of various paints, lacquers, chemicals, pigments, and varnishes. The site is situated on approximately 138 acres west of Lake Calumet between Interstate 94 and the Chicago South Shore and South Bend Railroad tracks. Access to the site is provided by several roads and rail spurs from the Chicago South Shore and South Bend Railroad. As the site is built on reasonably level ground there are no overall discernable drainages with the exception of one channel in the southeast corner. Surface runoff from the site is probably channeled to the local storm sewer system which probably empties into Lake Calumet.

There is only one obvious waste disposal operation within the site. There are two lined liquid waste lagoons (each about 125 x 125 feet) and two small unlined ponds near the center of the site. All four contain liquid but only the lagoons appear to contain waste liquids. The smaller pond (112 by 45 feet) appears to have vegetation and algae growth while the other pond (248 by 45 feet) contains a clear liquid. No outlets can be located for these four impoundments.

Two other areas of the site may have been involved with waste disposal at some time in the past. The first is a mound located in the southwest corner of the site. It is approximately 5 acres in size and rises about 15-20 feet above the surrounding site level. Also this mound is secured by a fence with the only access point along the south fence line. There are nine tank trailers parked near the mound. The second area is located in the southeast corner of the site. There are numerous areas of disturbed ground which may be nothing more than failed revegetation areas. However, an analysis of the topographic quadrangle (Figure 2) indicates this area was a terrain depression at the time of mapping. An analysis of the current imagery indicates no depression in this area and in fact a drainage channel leading offsite is present. It is therefore reasonable to assume that some type of filling activity has occurred at this location.

Thousands of 55-gallon drums are a major feature in this site. They can be found throughout the facility from small groups of 5-15 to stacks of several thousand. Numerous spill stains can be seen around various groups of drums although there is no indication that the spillage has migrated any distance from the spill point. Spill stains are also noted around the various rail- and truck-loading racks. Surface runoff could wash spilled waste material to the nearest storm sewer. There are numerous vertical and horizontal tanks present and all appear to be well contained.
